PHASE II INVESTIGATION / RADIOLOGICAL SURVEY

**Performed at
160 East Illinois Street
Chicago, Illinois
Performed for
Ms. Laurie Bain
Benchmark Project # 00299A**

**Subject: Phase II Investigation / Radiological Survey Performed at
160 E. Illinois Street, Chicago, Illinois,
Benchmark Project # 00299A**

RE: Radiological Survey of 160 E. Illinois St.

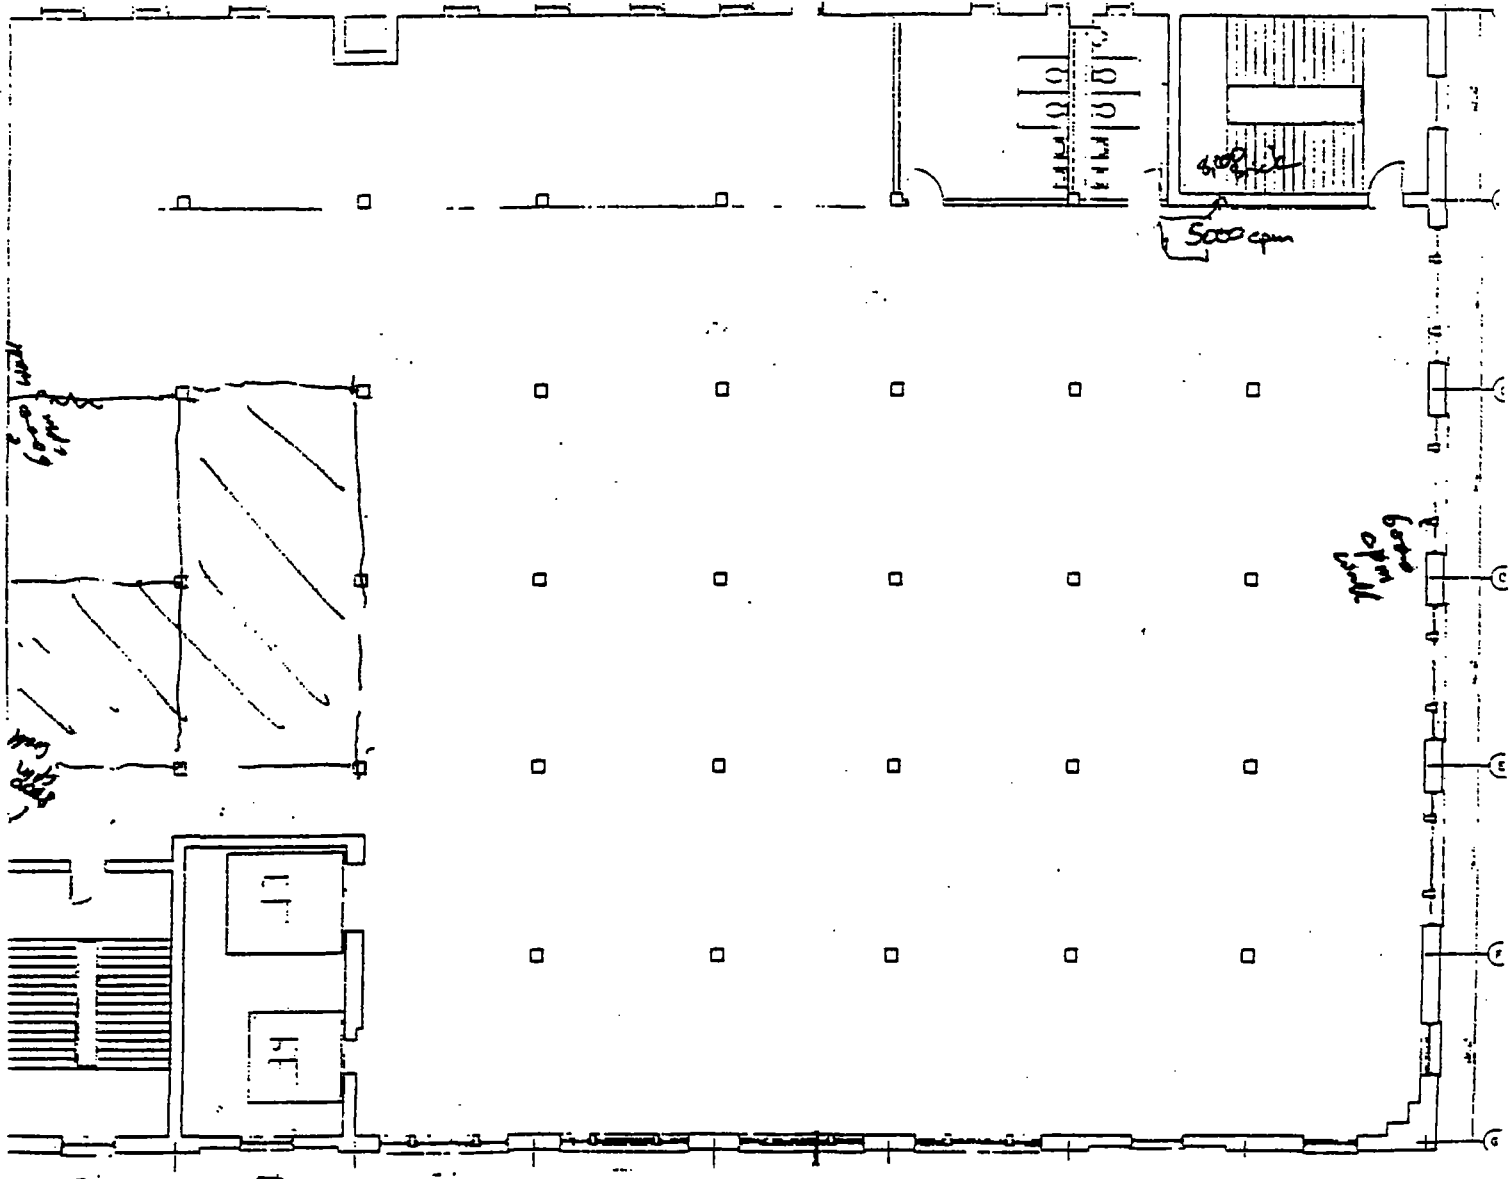
5th Fl.

LL Bldg
had many
hot spots in center
of room
